Don Catchment Rivers Trust

River Loxley: Fish Passage Scoping Study

Options Report

Issue | 14 May 2013

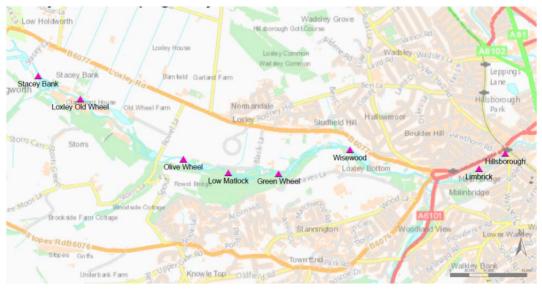
Figure 1: River Loxley Weirs

Arup has been commissioned by the Don Catchment Rivers Trust to undertake a feasibility study for 7 barriers to fish migration on the River Loxley between Hillsborough Weir and Loxley Old Wheel Weir. The sites are shown in Figure 1.

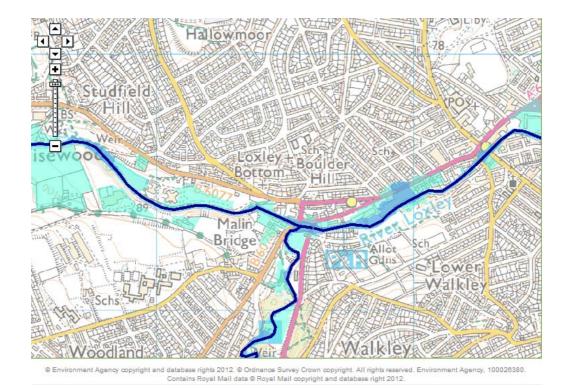
Figure 2: River Loxley Flood Map Hillsborough to Wisewood

Dark blue shading identifies areas vulnerable to flooding from rivers or the sea during a 1 in 100 year return period storm event if there were no flood defences in place. Light blue shading shows flooding from rivers or the sea if there were no flood defences during a 1 in 1000 year return period storm event.

Flood maps have been downloaded from the Environment Agency's website for the Loxley area. Extracts from these maps are shown in Figure 2 to Figure 4.

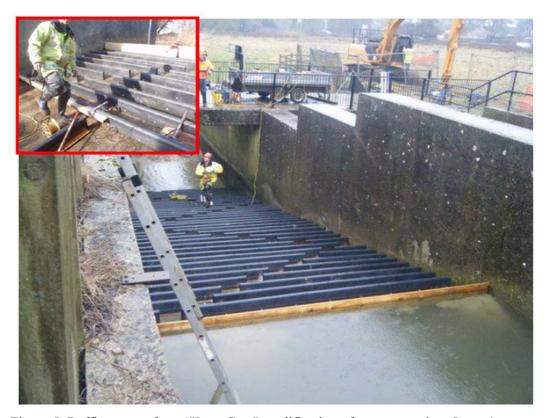
A pilot study has been carried out on the River Asker in Bridport, Dorset into the use of "Low-cost modifications of the Crump weir to improve fish passage: Science Report SC010027". In this case the weir was much larger than weirs traditionally using low cost modifications/easements. Baffles were proposed over one section of the weir face formed of recycled plastic. A meandering gap is formed through the baffles to allow for fish passage, this is shown in the figure below.

Figure 5: Baffle system from "Low Cost" modification of a crump weir at Jessop's Avenue, Bridport to improve fish passage"

The report concludes that after installation the weir is passable to large migratory fish as well as some smaller fish.

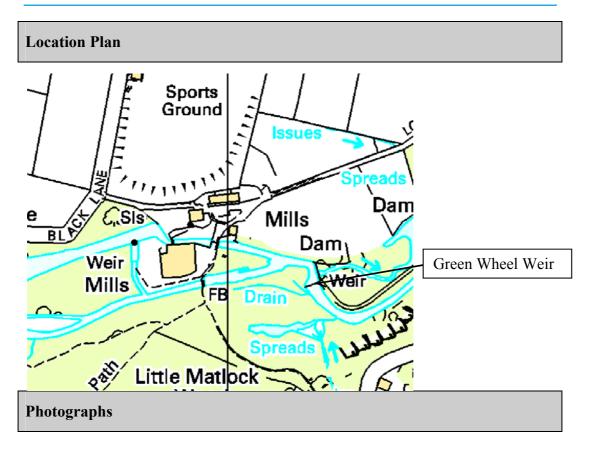
Figure 13: View from the right bank looking upstream at the weir.

- The river channel has naturally begun to cut a by-pass channel along the right side of the channel, through the inside of the meander bend. This channel is currently dry under typical and low flow conditions, but is expected to become active during high flow events. Accordingly, there is potential scope to formalise this natural by-pass channel in order to provide fish passage and improve biological and sediment continuity around the weir. This would need to be designed to ensure that: adequate flow depths to support fish passage are maintained under normal conditions; sediment deposition at the downstream end of the by-pass channel (currently a natural deposition zone) is discouraged to prevent the effectiveness of this solution being compromised (e.g. suitable attraction flows and depths are maintained); and future channel erosion and instability risk is adequately controlled.

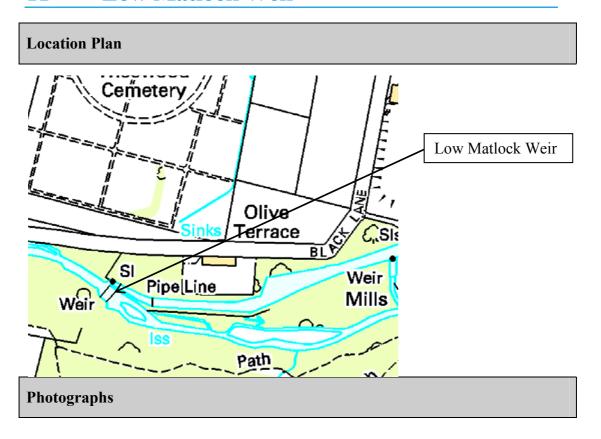
Figure 16: View from the right bank looking upstream

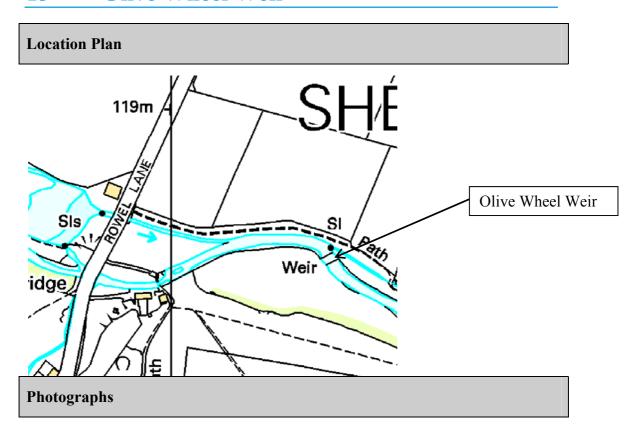
Figure 19: View from the left bank looking upstream

- The weir is positioned on the downstream side of a meander bend, so that flow velocities during high flow conditions are likely to be concentrated along the left bank / side of the weir. However, the presence of an in-channel tree immediately downstream of the weir towards the left side of the channel, has encouraged sediment deposition to its lee and the formation of a cobble mid bar. Resultantly, typical flows immediately downstream of the weir comprise runs and small cascades, which are largely focused along the right side of the channel on the inside of the meander bend. Any works to improve fish passage that are targeted on the left side of the weir would likely require the removal of the tree and excavation of the mid bar (and potentially replacement along the right bank), in order to ensure attraction flows are suitable whilst discouraging further deposition around the approach to the fish pass solution that may impact upon its effectiveness.

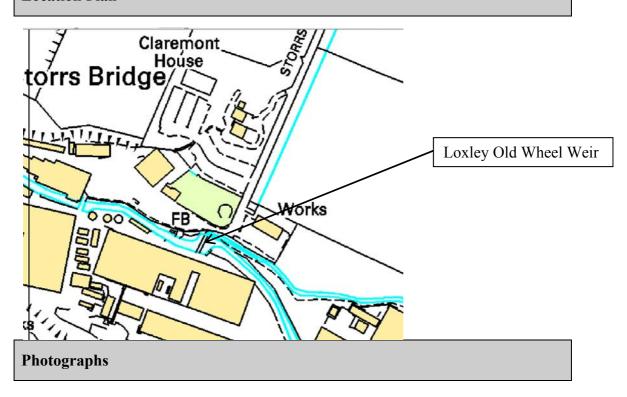
Figure 22: View of weir from left bank.

- The existing aquatic habitat quality (particularly potential spawning habitat) immediately upstream of the weir appears to be poor. The river channel is channelised and highly constrained at this location due to the historical mill developments; which in turn has promoted channel incision (bed scour) and resulted in poor riparian and marginal habitat value. In combination with the back-ponding of flows caused by the presence of the weir, this has resulted in and over-deep channel with a lack of hydromorphological diversity; which is unlikely to provide suitable spawning and or refugia habitat for migratory fish. Channel substrates immediately upstream of the weir were not visible during the site visit due to water depths and poor access along the channel; however, these are expected to comprise predominately coarse cobble and boulder sized sediment with overlying deposits of fines (accreted due to the effect of the weir on flow velocities and sediment transport capacity along this reach).
